TECHNICAL REPORT CERC-85-10

# WAVE STABILITY TESTS OF DOLOS AND STONE REHABILITATION DESIGNS FOR THE EAST BREAKWATER, CLEVELAND HARBOR, OHIO

Experimental Model Investigation

Coastal Engineering Research Center

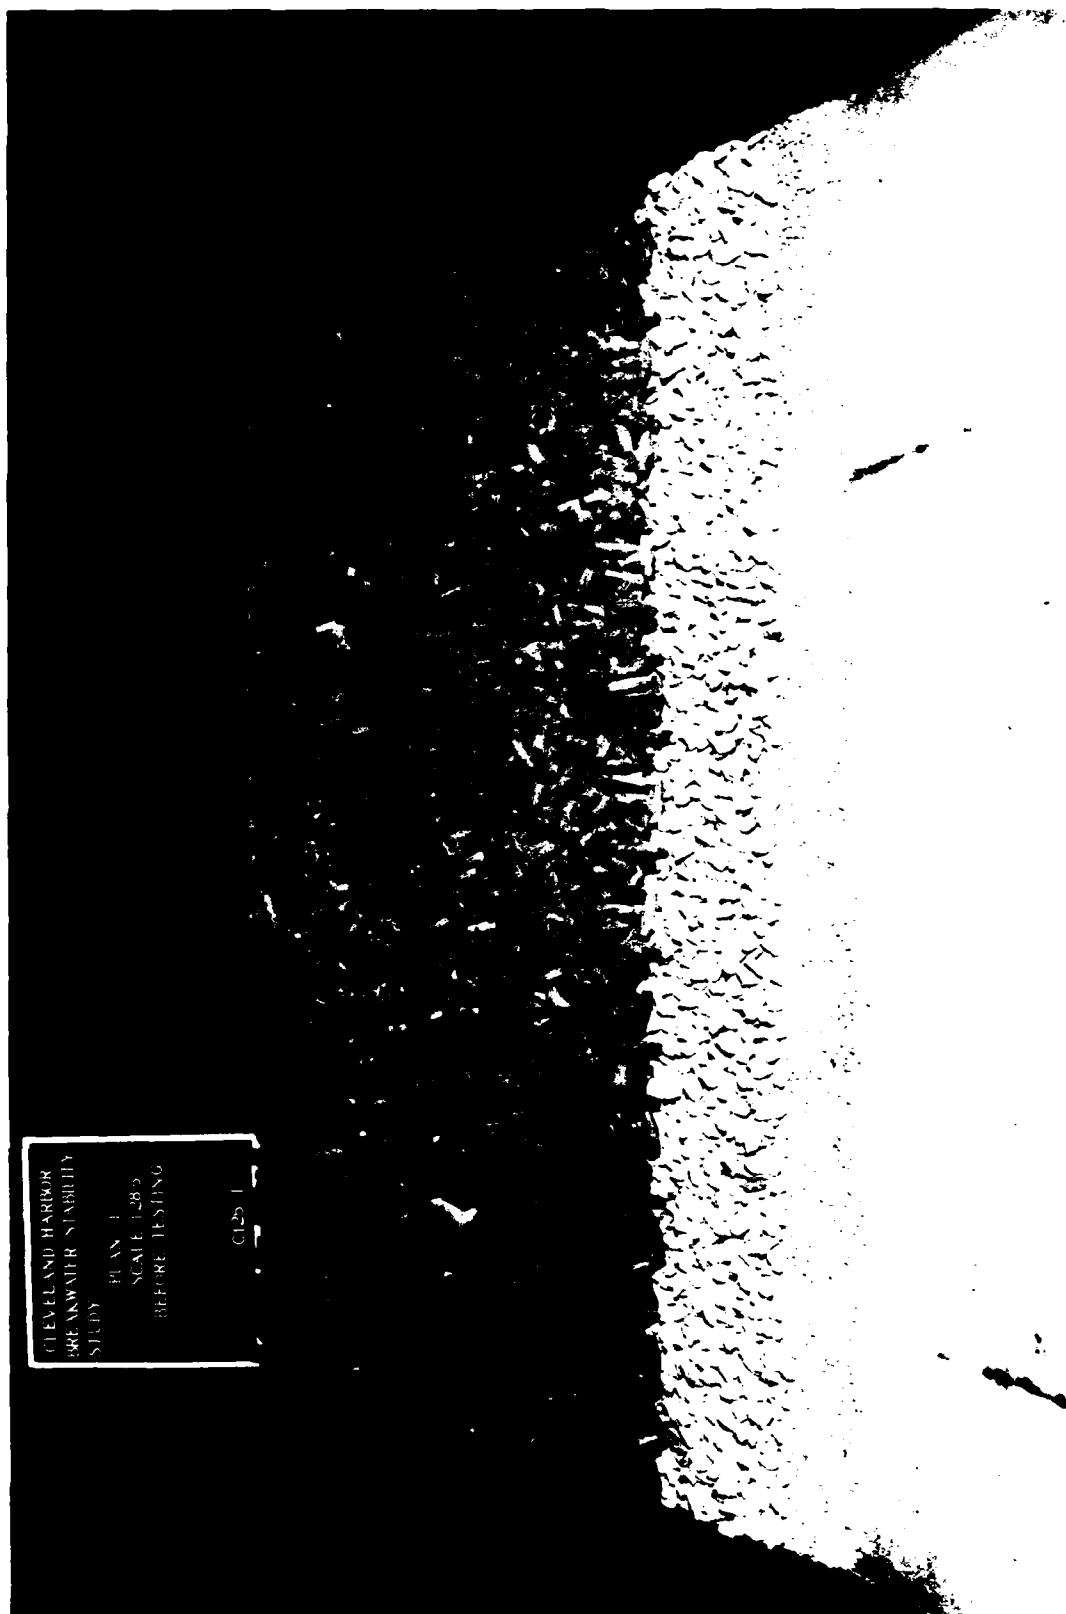
Photo 1. Lakeside view of Plan 1 before testing, first test section

13. The proposed 4-ton dolos rehabilitation section (Plan 1, Plate 1 and Photos 1 and 2) was a two-layer system of randomly placed dolosse on a 1V-on-2H lakeside slope. The dolosse coverage extended from a 13-ft-wide crown (elevation +10.3 ft lwd) to a toe berm elevation of -22.0 ft lwd. Plan 1 was exposed to the wave and swl conditions of Hydrograph A (Table 1). During Step 1, minor to moderate rocking of several dolosse was observed around the swl and on the upper slope and crown. Two dolosse were displaced from the dolos crown area onto the old laid-up stone crown and one of these dolos then was displaced onto the harbor-side slope during a later cycle of Step 1. It also was noted that the combined upslope packing and downslope consolidation of the dolos armor around the swl created an area of dolos separation around the swl. In this area, the dolos armor porosity was much higher than other areas of the structure and the underlayer had become very visible but was showing no signs of movement. Four additional dolosse were displaced from the crown onto the harbor-side slope and one dolos originally placed below the swl was displaced down the lakeside slope during Step 2. The severity of dolos rocking and number of units rocking seemed to increase slightly at the start of this step, but appeared to decrease in severity by the end of Step 2. The wave conditions of Steps 1 and 2 produced moderate to significant overtopping while major overtopping was observed during Step 3 of Hydrograph A. It appeared that the 9-sec waves were not impacting as hard on the dolos, but that most of the wave energy was passing over the breakwater crown and was being dissipated on the harbor-side of the structure. No additional displacement occurred during this step and the amount of dolos rocking appeared to have decreased from that observed during the previous step. At the end of Hydrograph A, the dolos armor showed minor spot damage on the breakwater crown, slight localized damage on the lower lakeside slope, and moderate amounts of dolos reorientation around the swl (Photos 3 and 4). The dolos reorientation around the swl was the result of the upslope packing and downslope consolidation of dolosse that occurred during Step 1 and did not seem to increase in severity during Steps 2 and 3 of Hydrograph A.

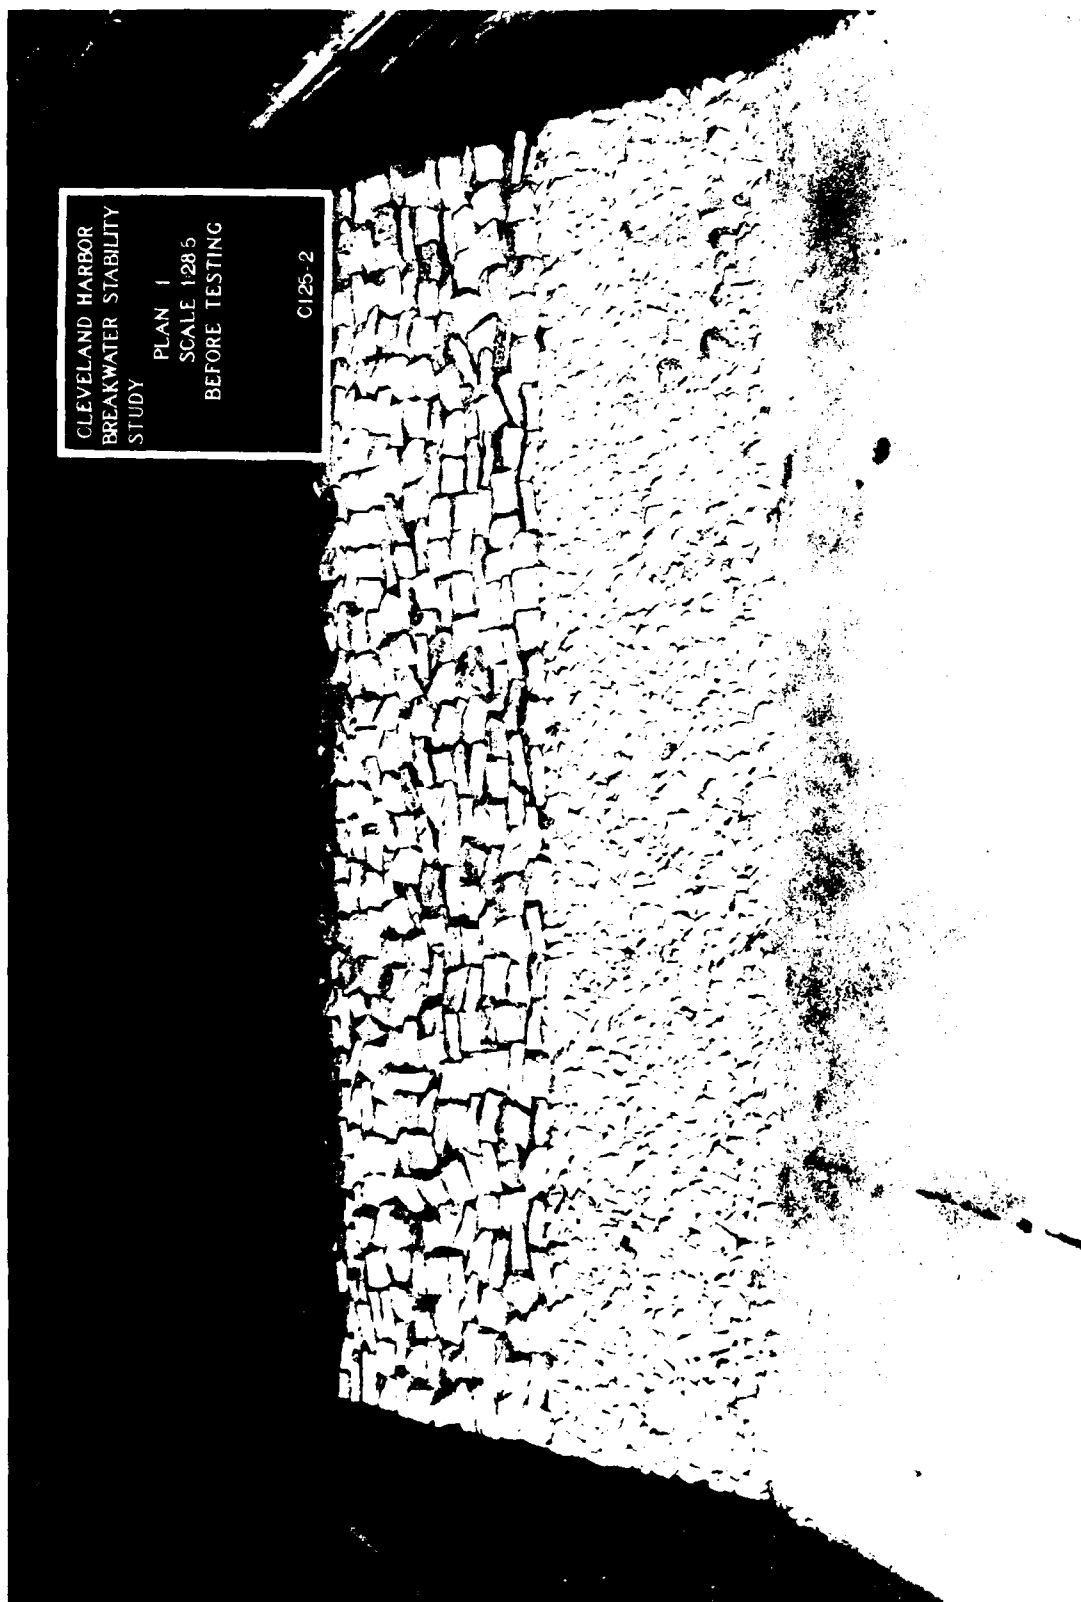
Photo 2. Harbor-side view of Plan 1 before testing, first test section

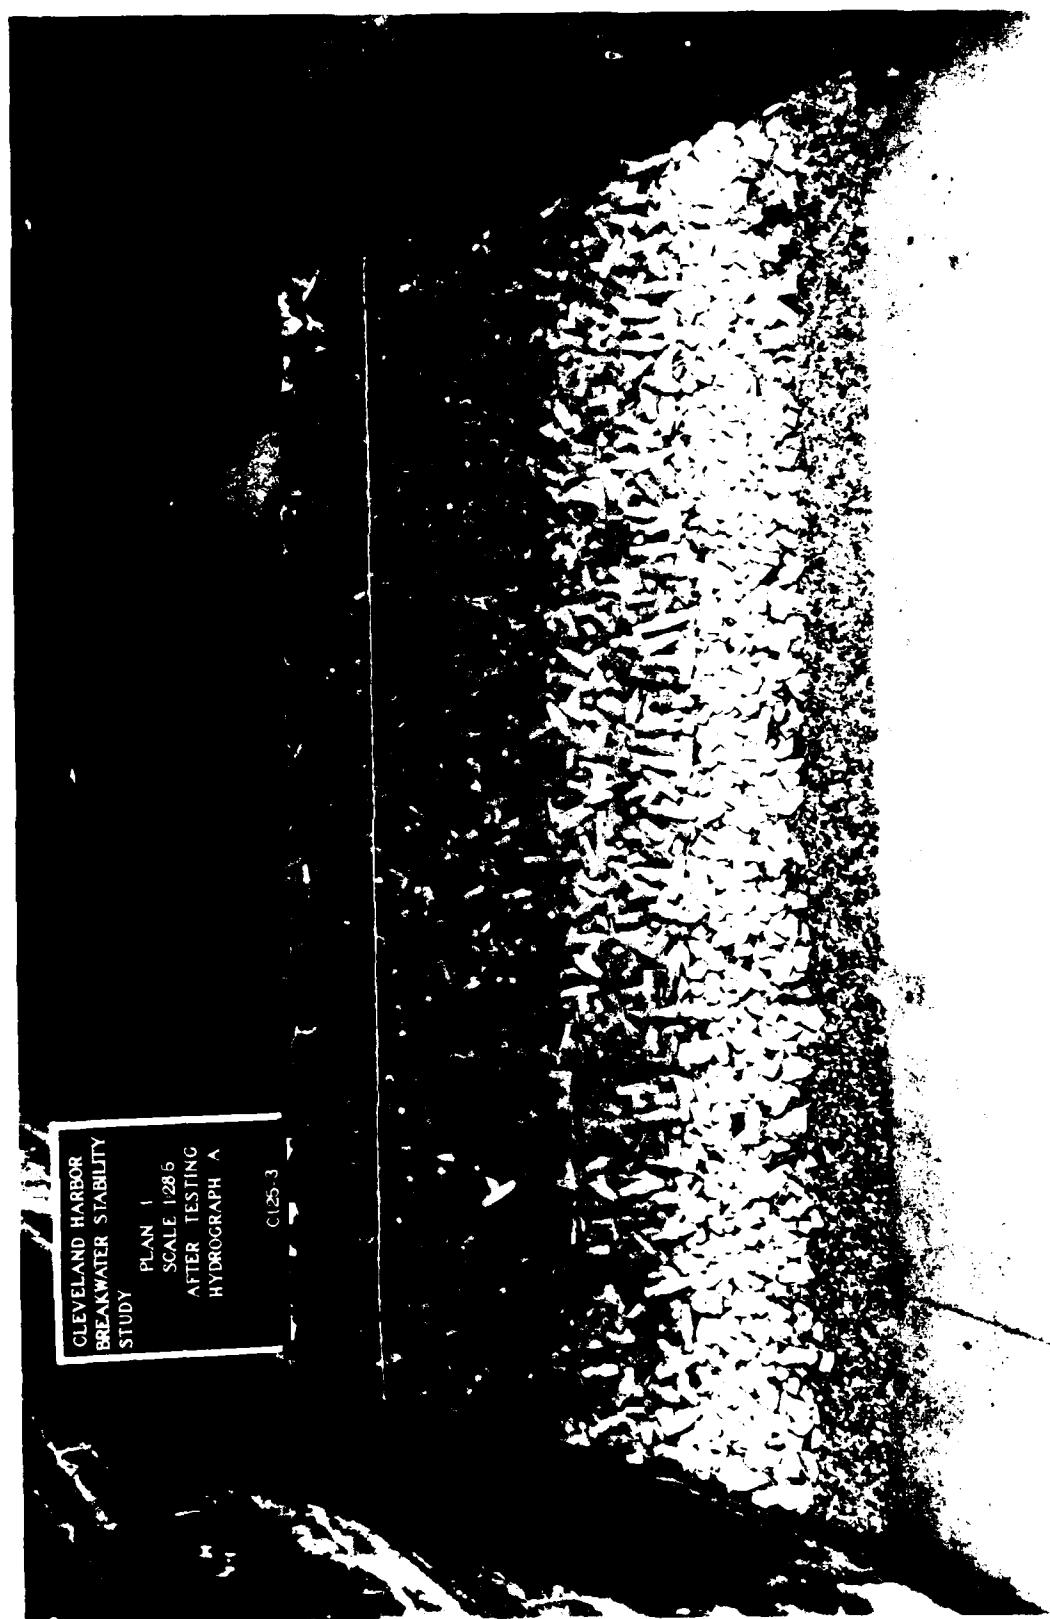
Photo 3. Lakeside view of Plan 1 after testing Hydrograph A, first test section

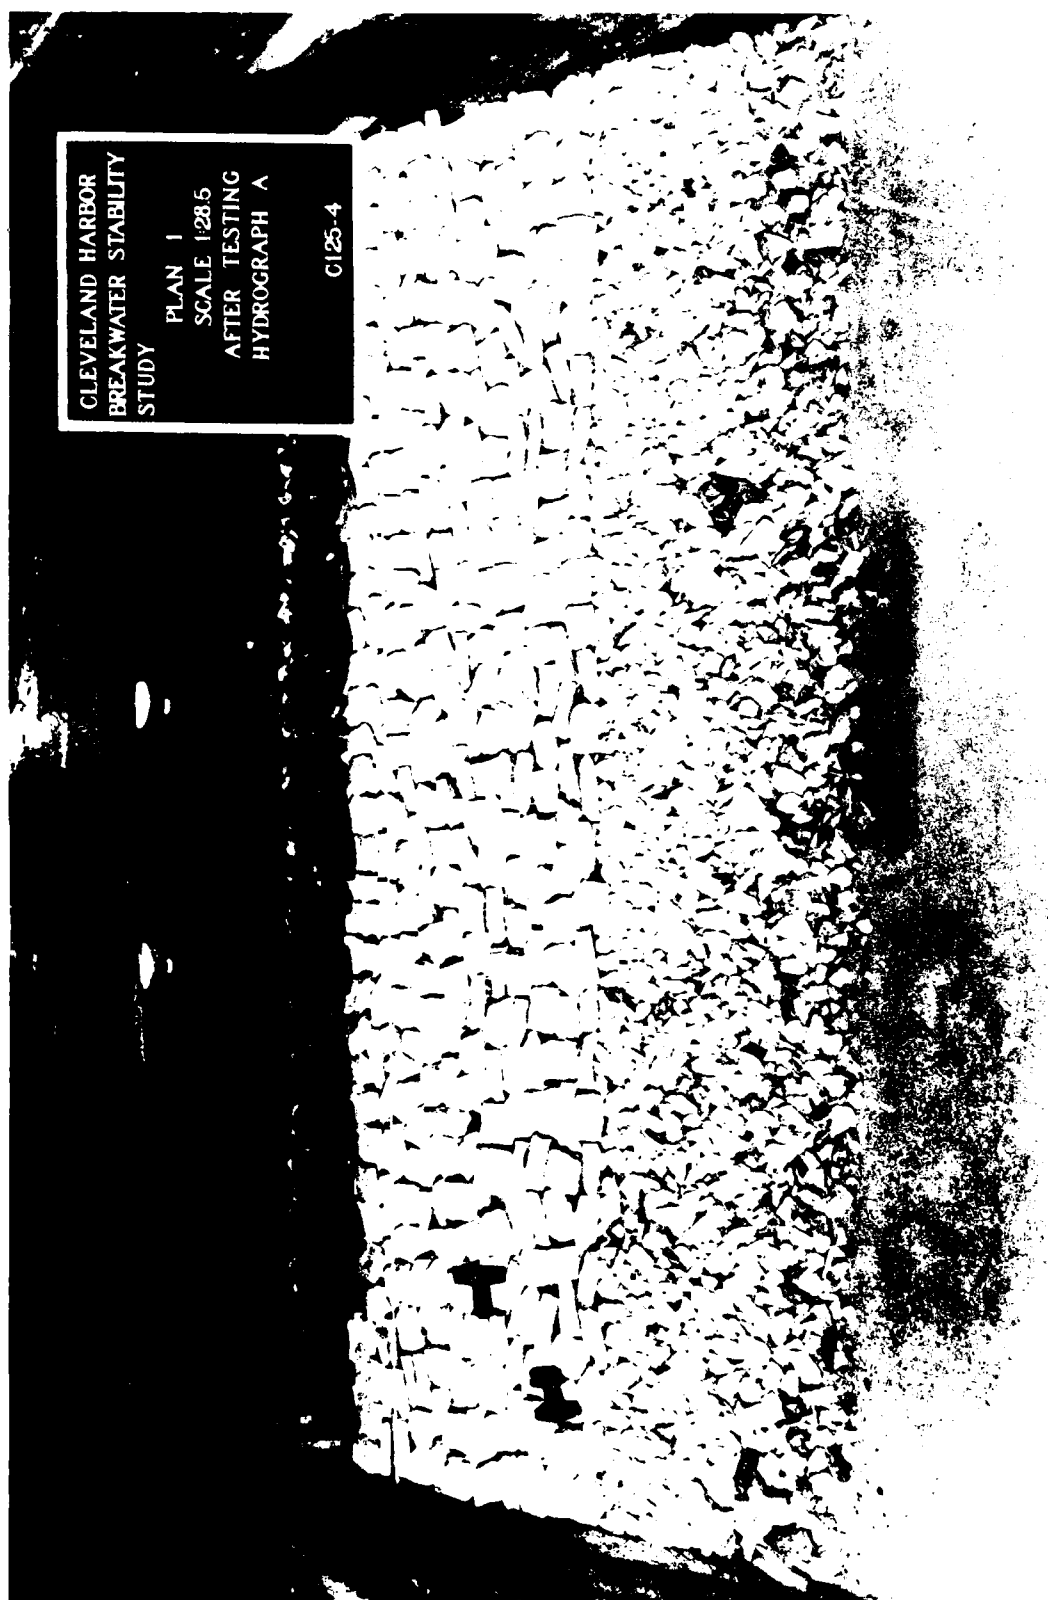
Photo 4. Harbor-side view of Plan 1 after testing Hydrograph A, first test section

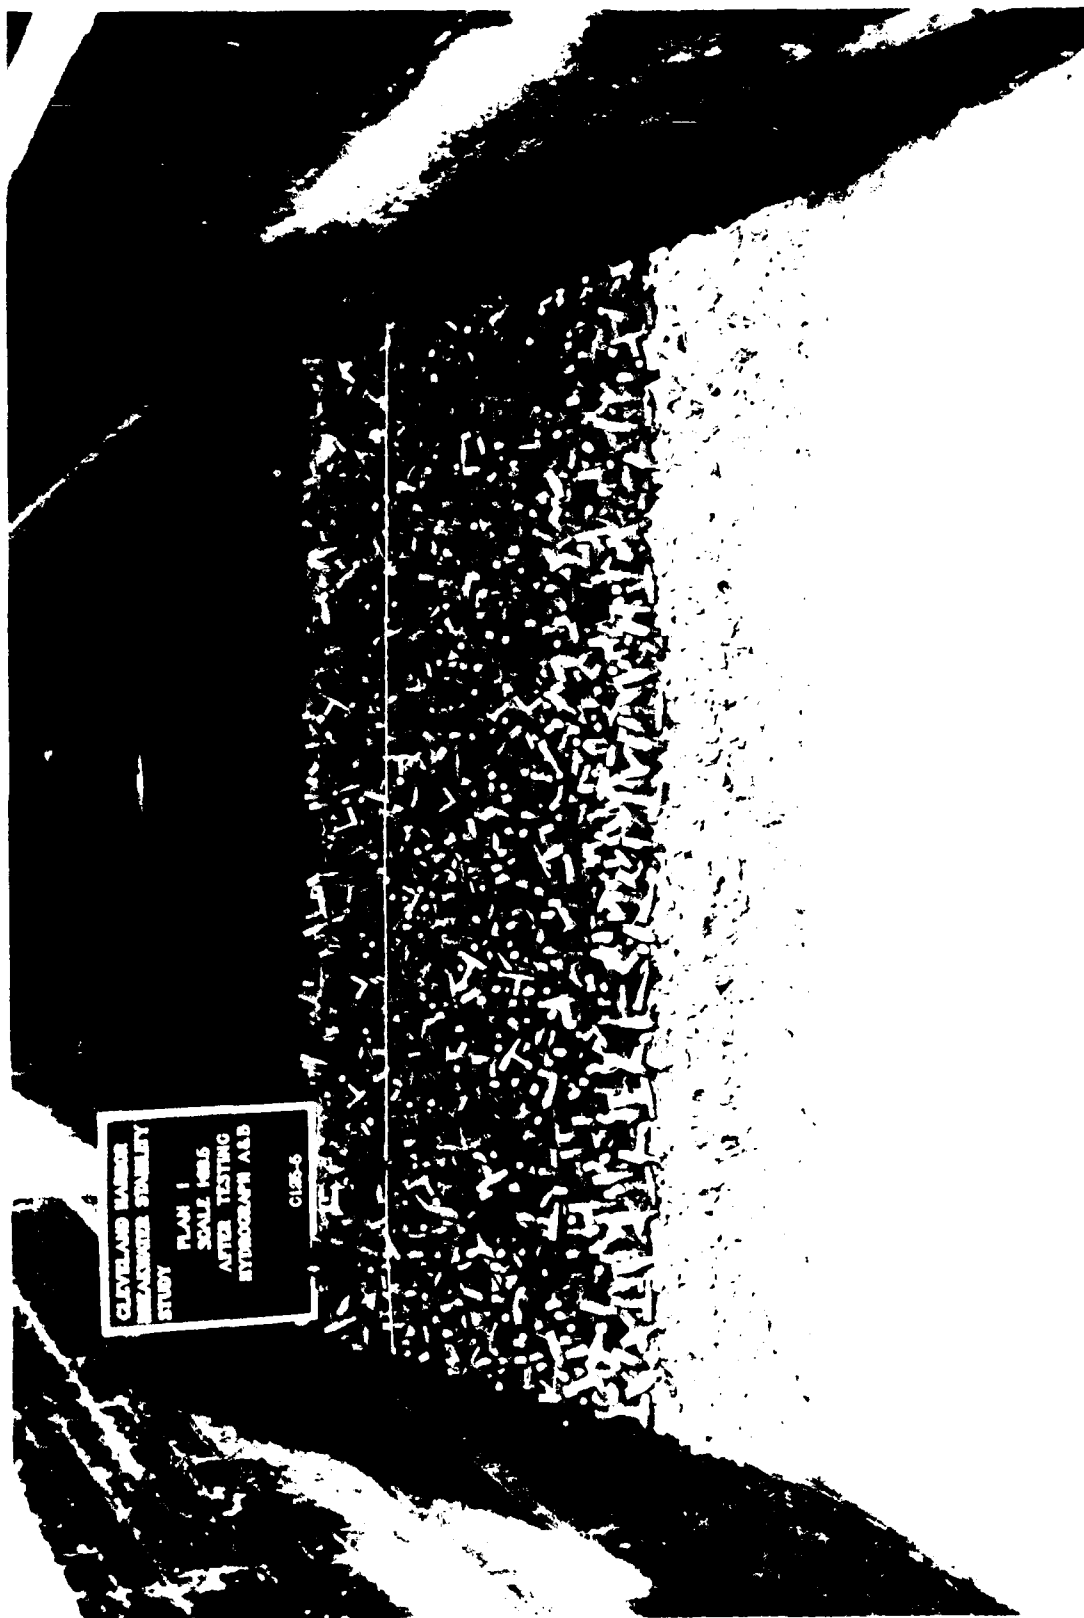
Photo 5. Lakeside view of Plan 1 after testing Hydrographs A and B, first test section

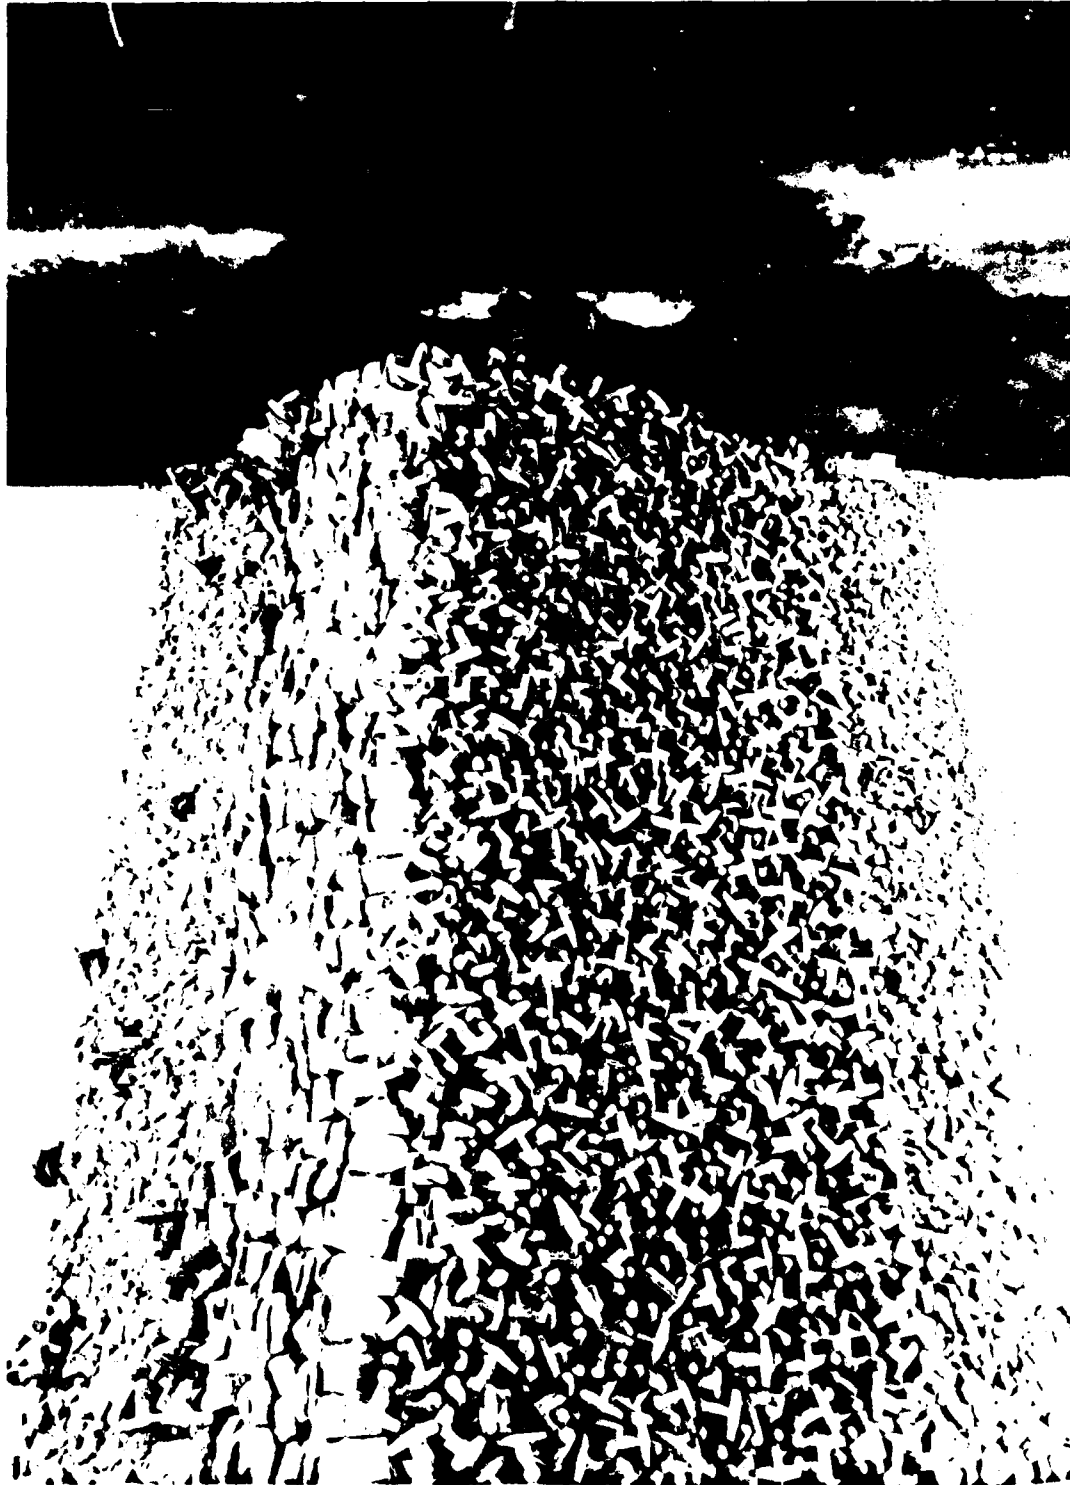
Photo 6. Overhead view of Plan 1 after testing Hydrographs A and B, first test section

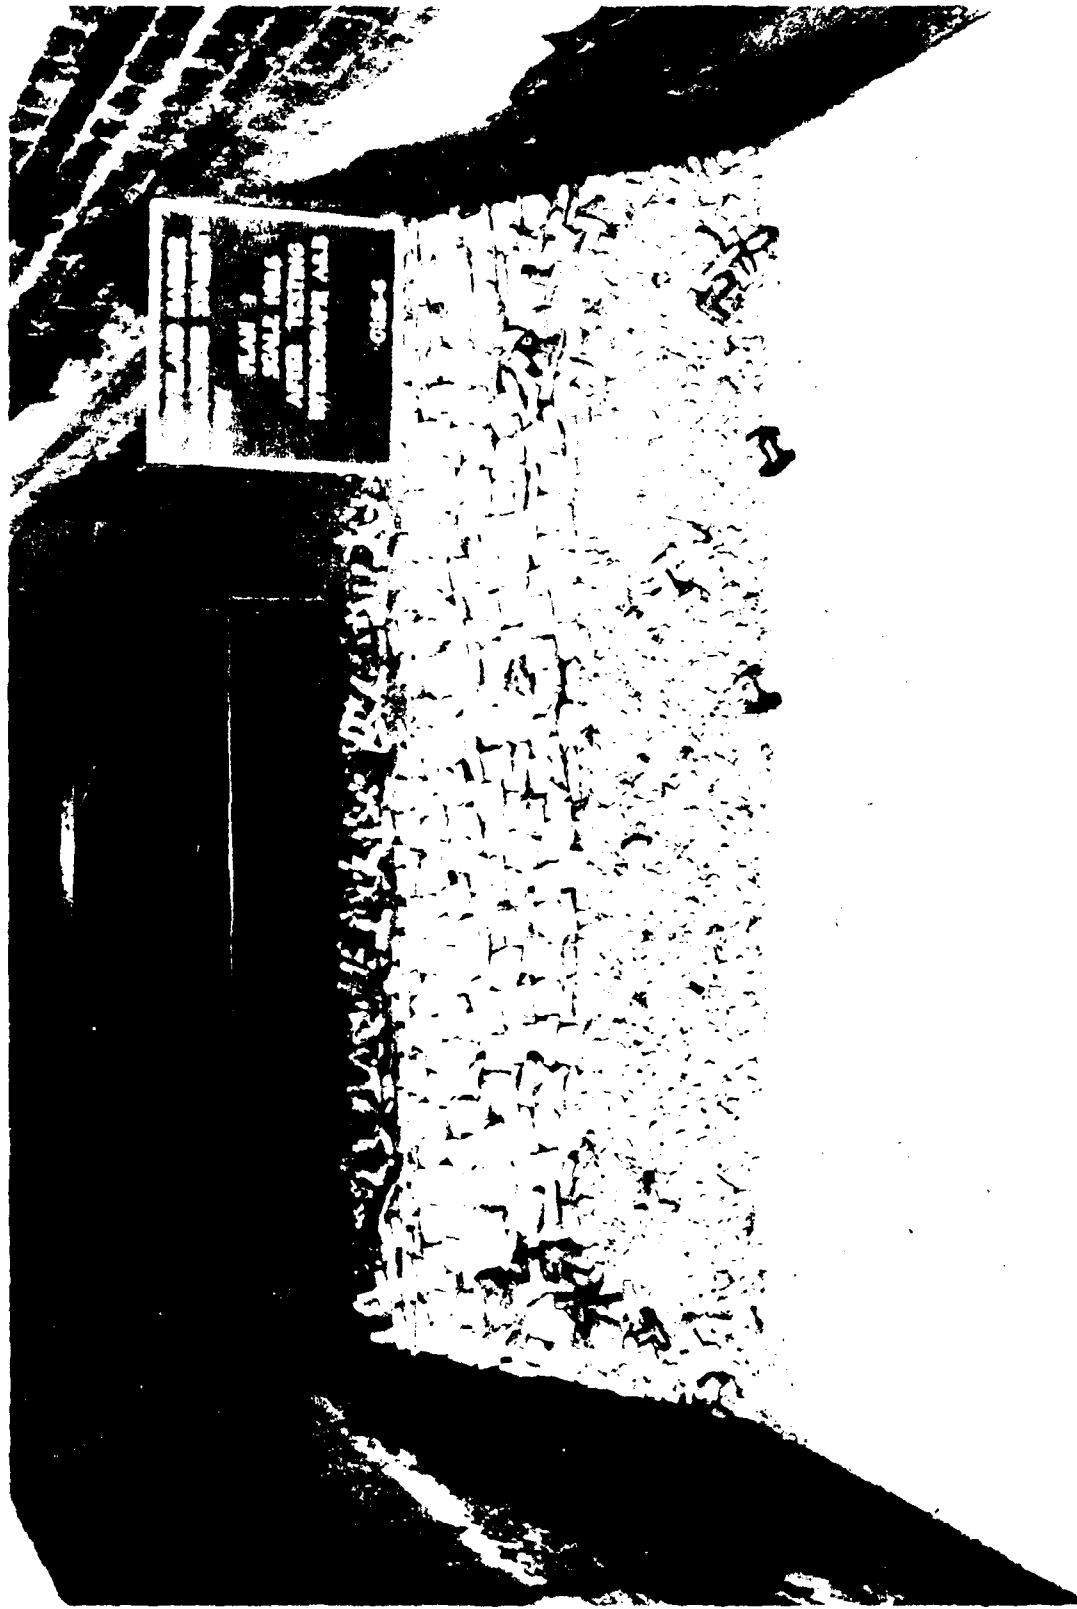
Photo 7. Harbor-side view of Plan 1 after testing Hydrographs A and B, first test section

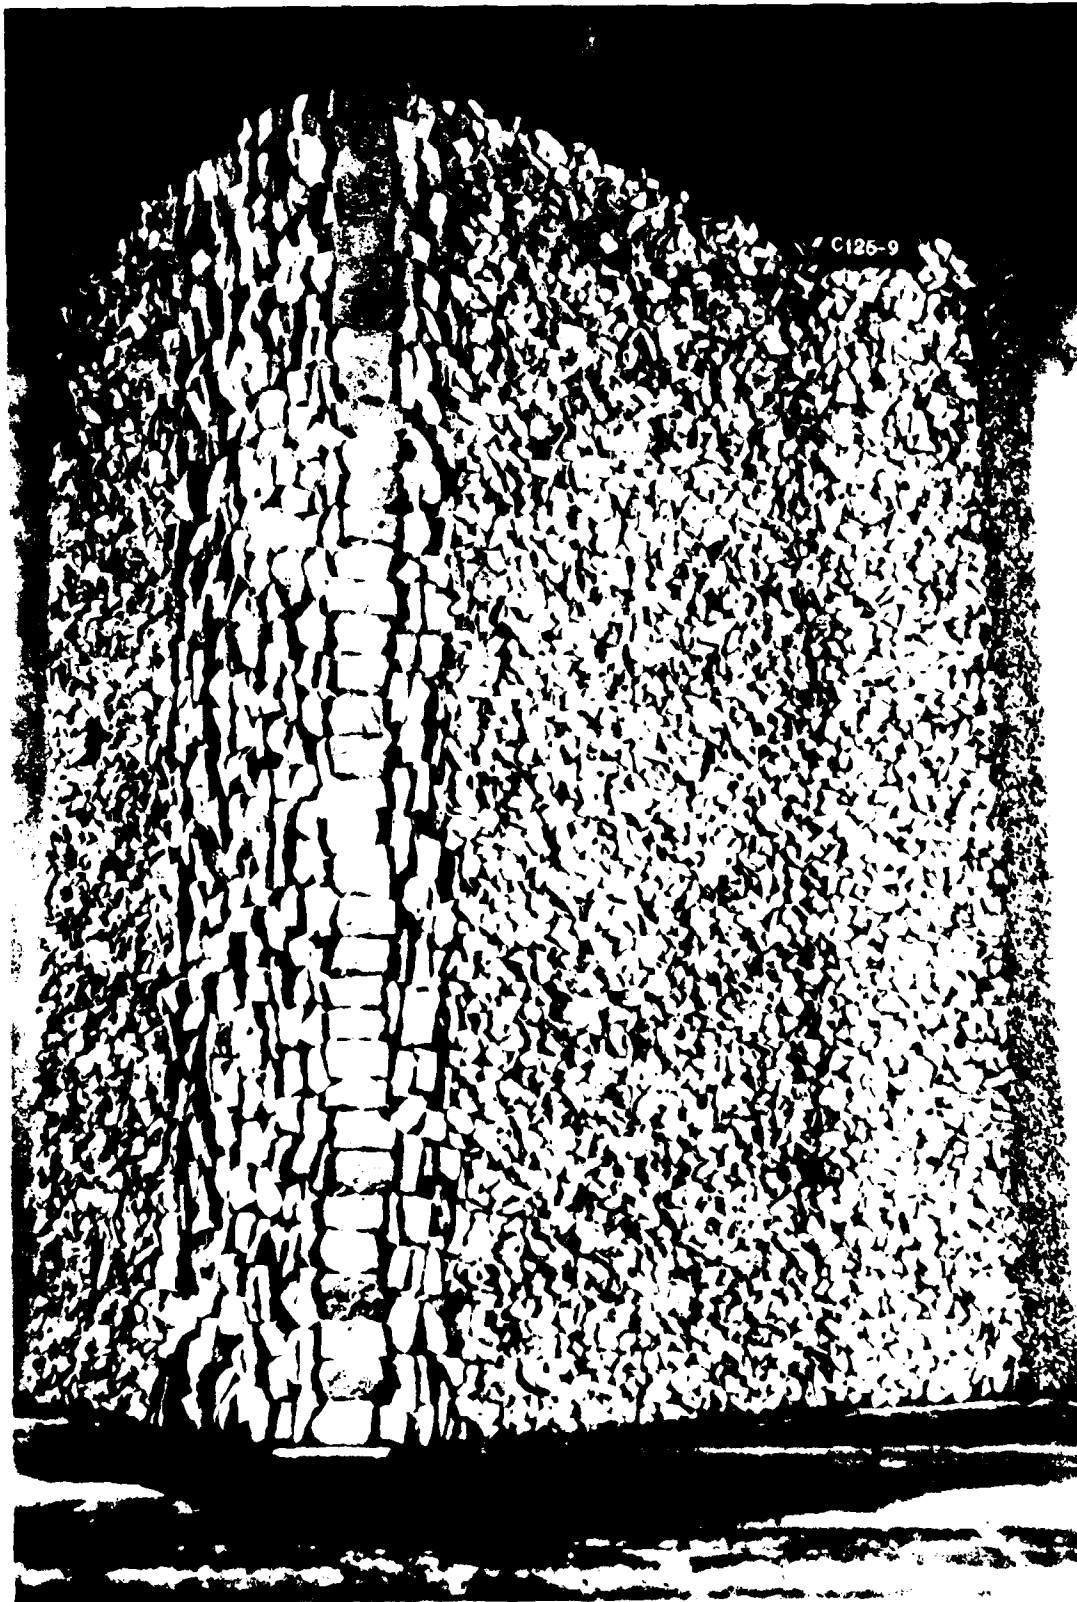
Photo 9. Overhead view of Plan 1 prior to placement of dolos armor, second test section

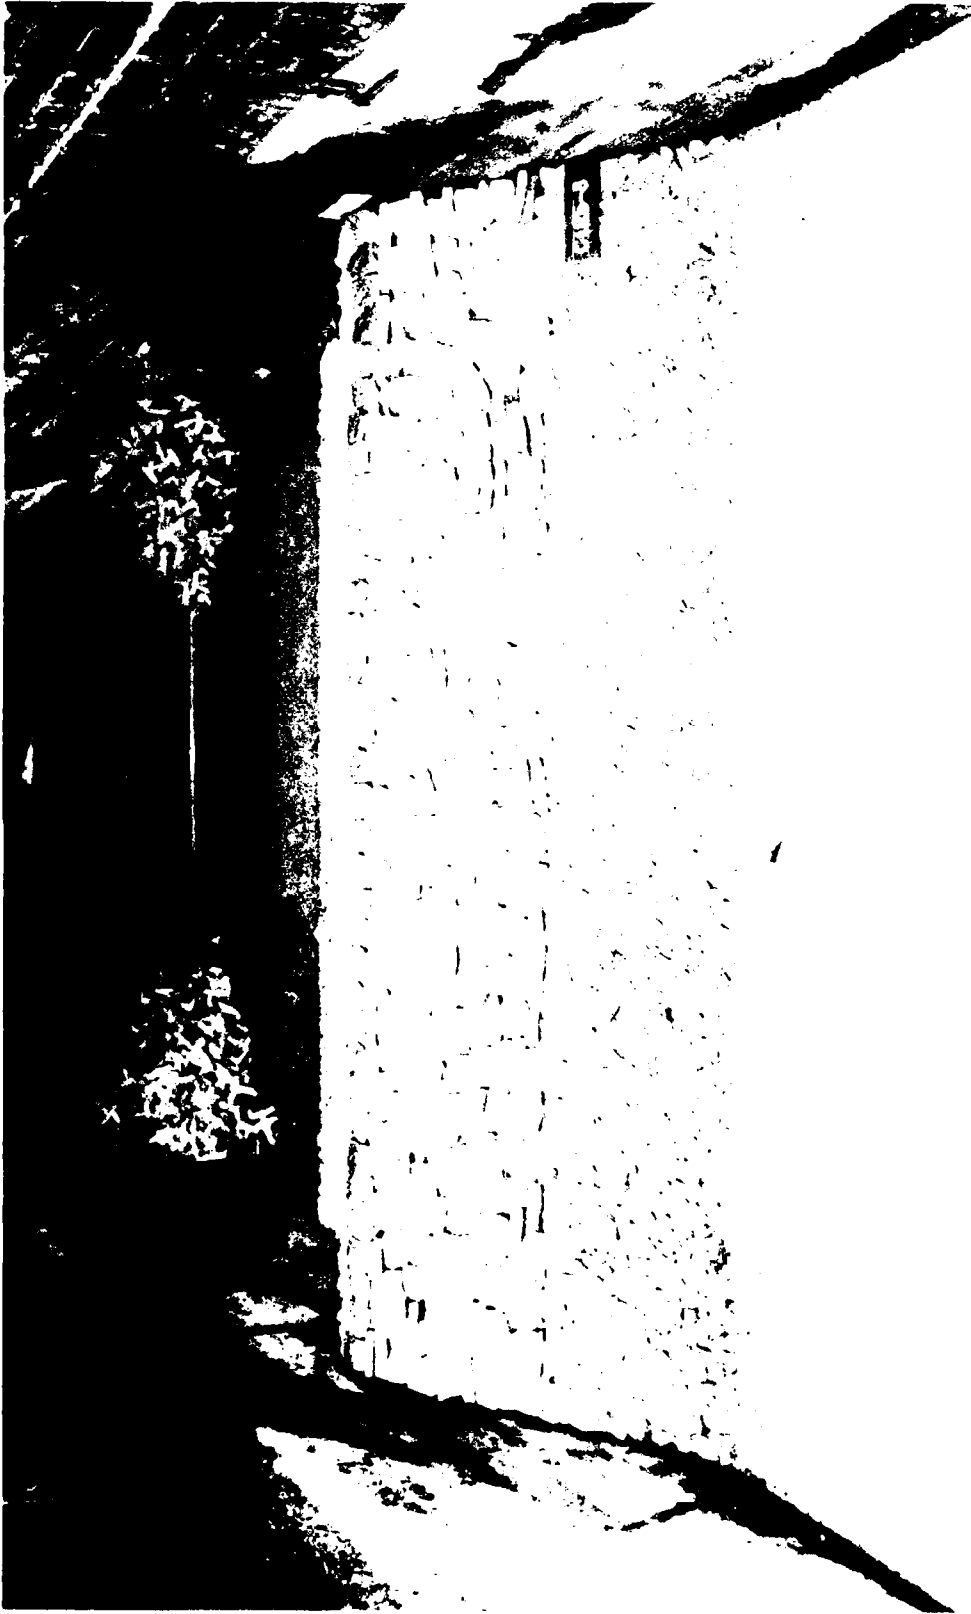
Photo 10. Harbor-side view of Plan 1 prior to placement of dolos armor, second test section

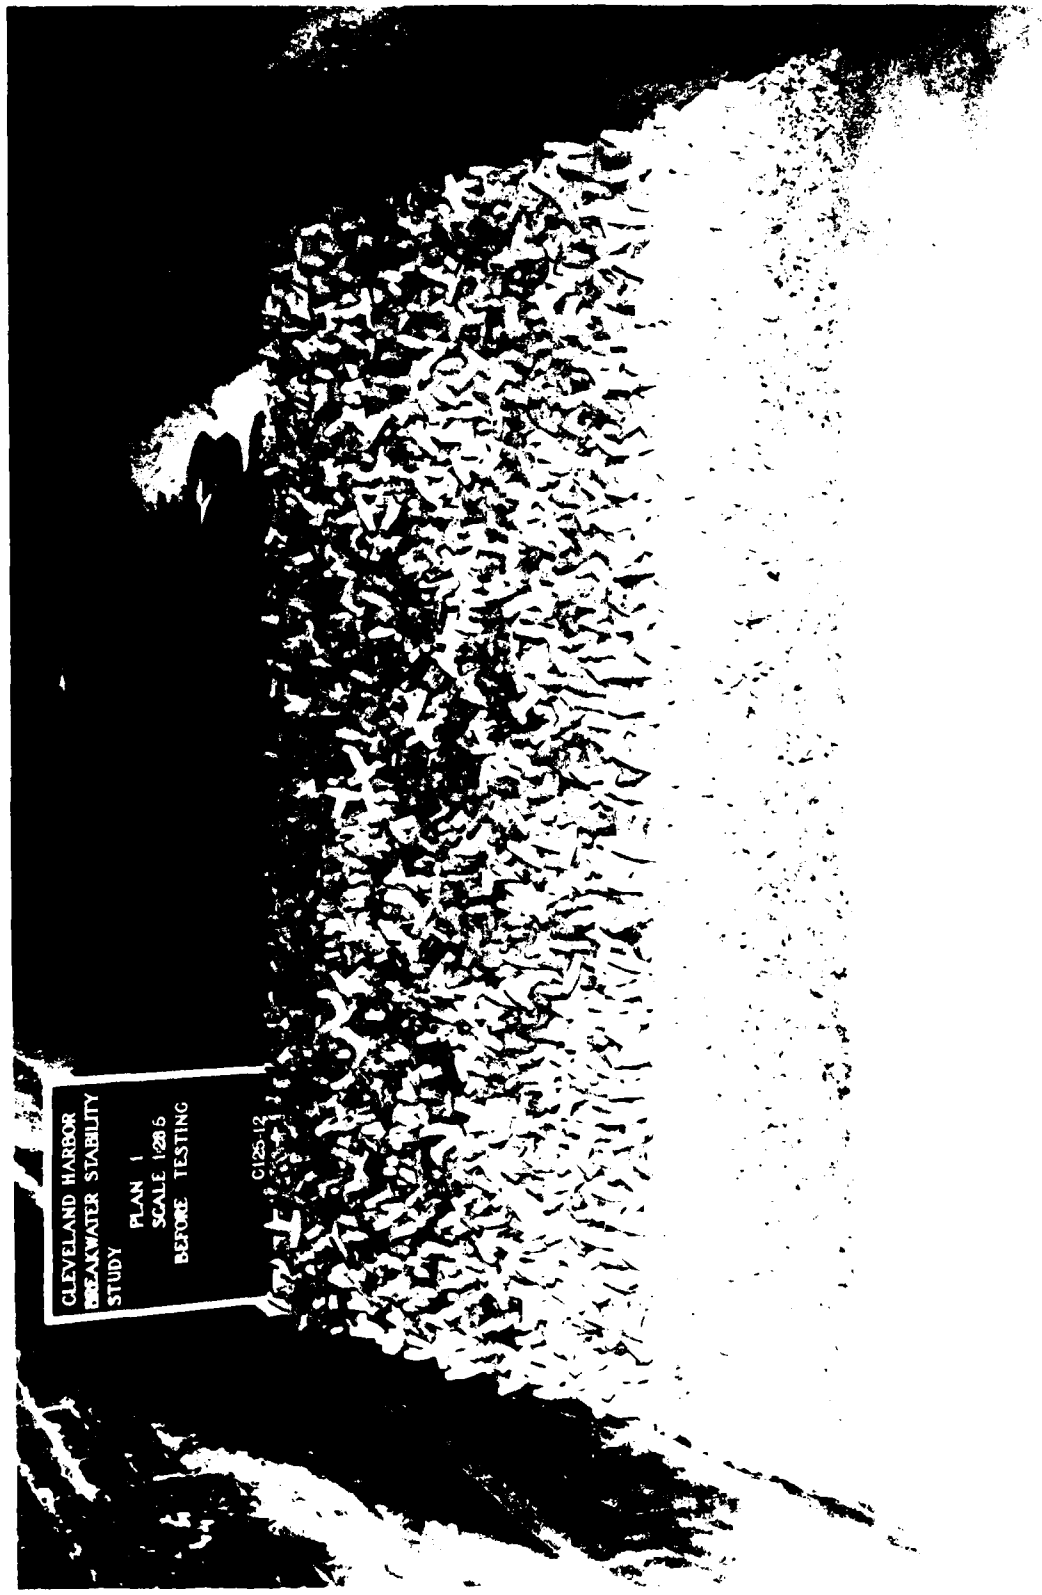
Photo 11. Lakeside view of Plan 1 before testing, second test section

(Photos 11 and 12). The structure once again was exposed to the wave and swl conditions of Hydrograph A. By the end of the test, the dolos crown showed major damage with 35 dolosse displaced down onto the harbor-side slope and 5 additional crown dolosse had been displaced shoreward but had not moved down onto the harbor-side slope (Photos 13-15). Only one dolos was displaced on the lower lakeside slope. Several dolosse on the upper slope and around the swl and crown exhibited minor to major in-place rocking throughout the test and armor unit displacement did not subside by the end of the test. The hydrograph was not extended since it was thought that damage (dolos displacement) already had exceeded a desirable level. Due to the extensive damage accrued during Hydrograph A it was decided that there was no need to expose the section to Hydrograph B.

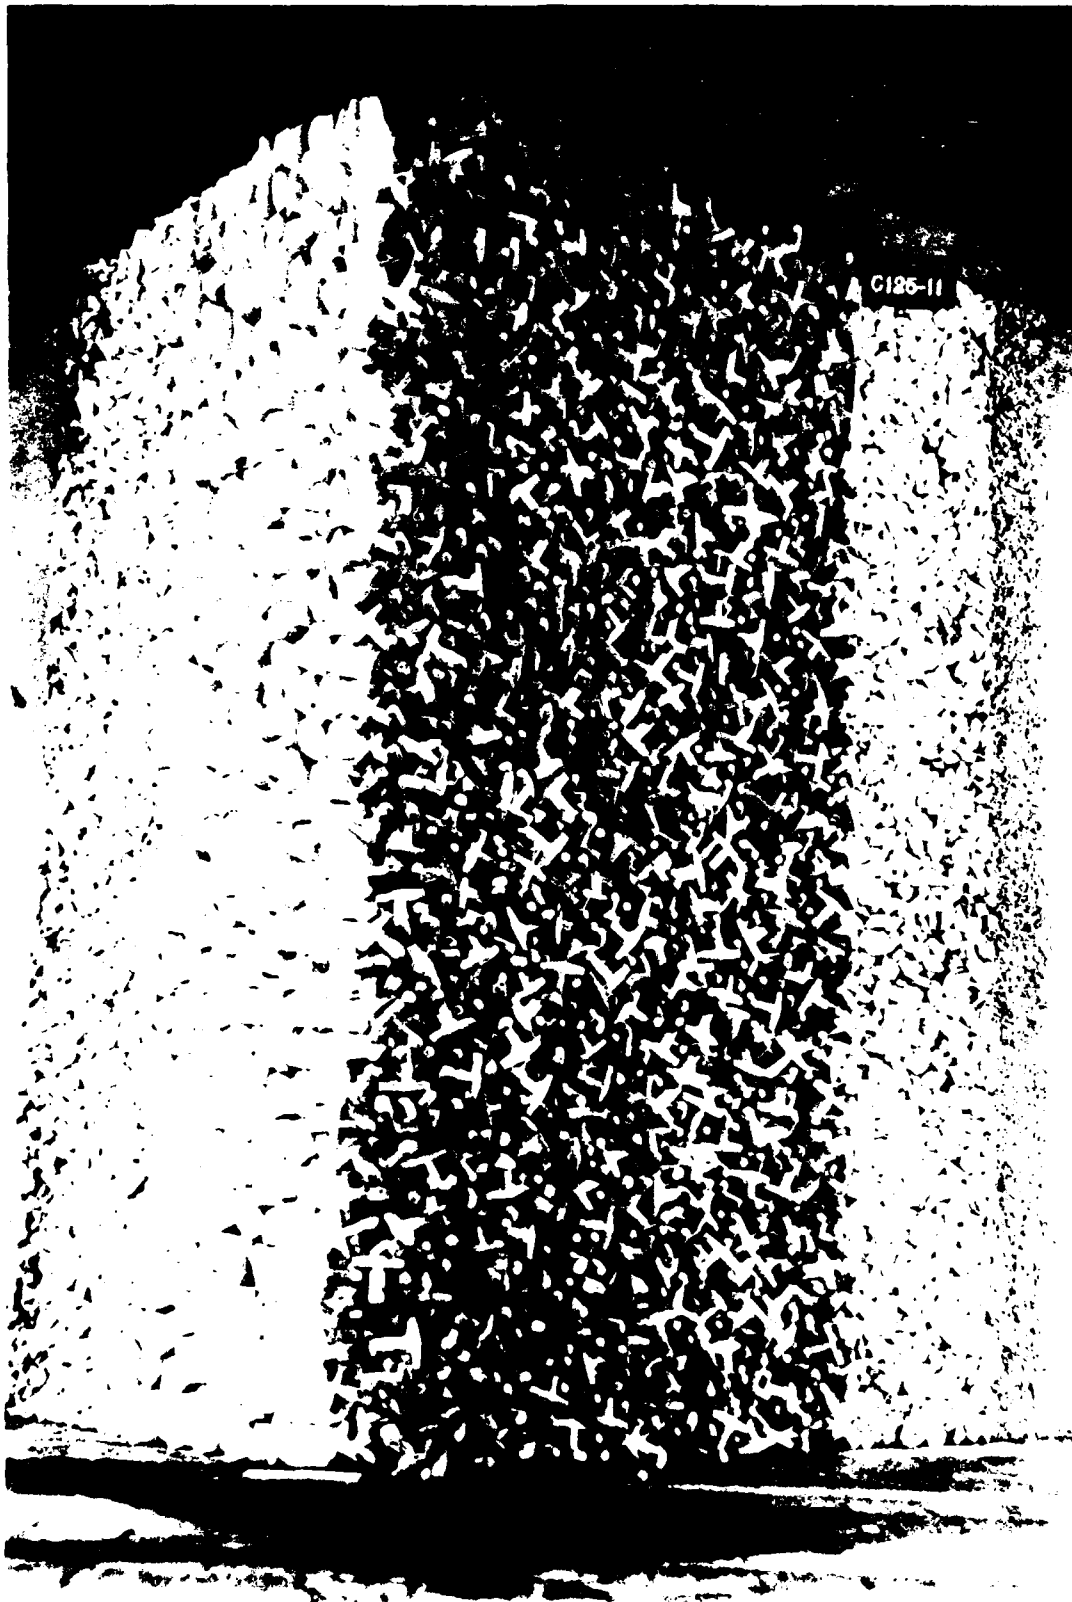
Photo 12. Overhead view of Plan 1 before testing, second  
test section

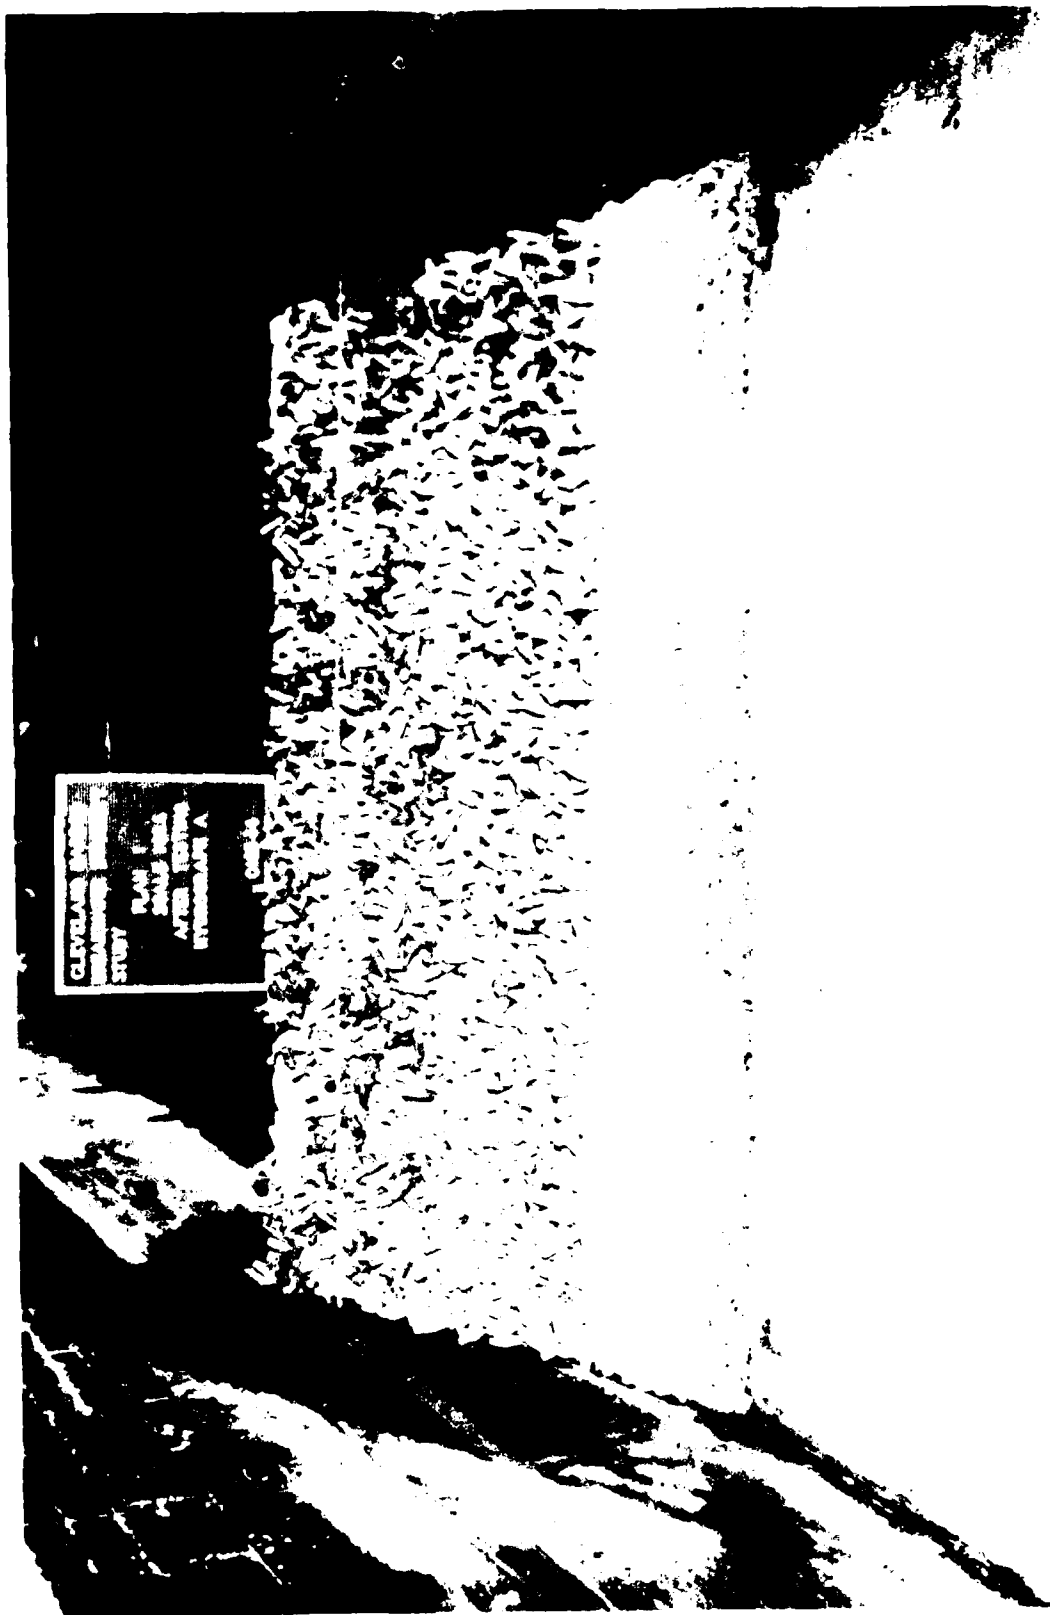
Photo 13. Lakeside view of Plan 1 after testing Hydrograph A, second test section

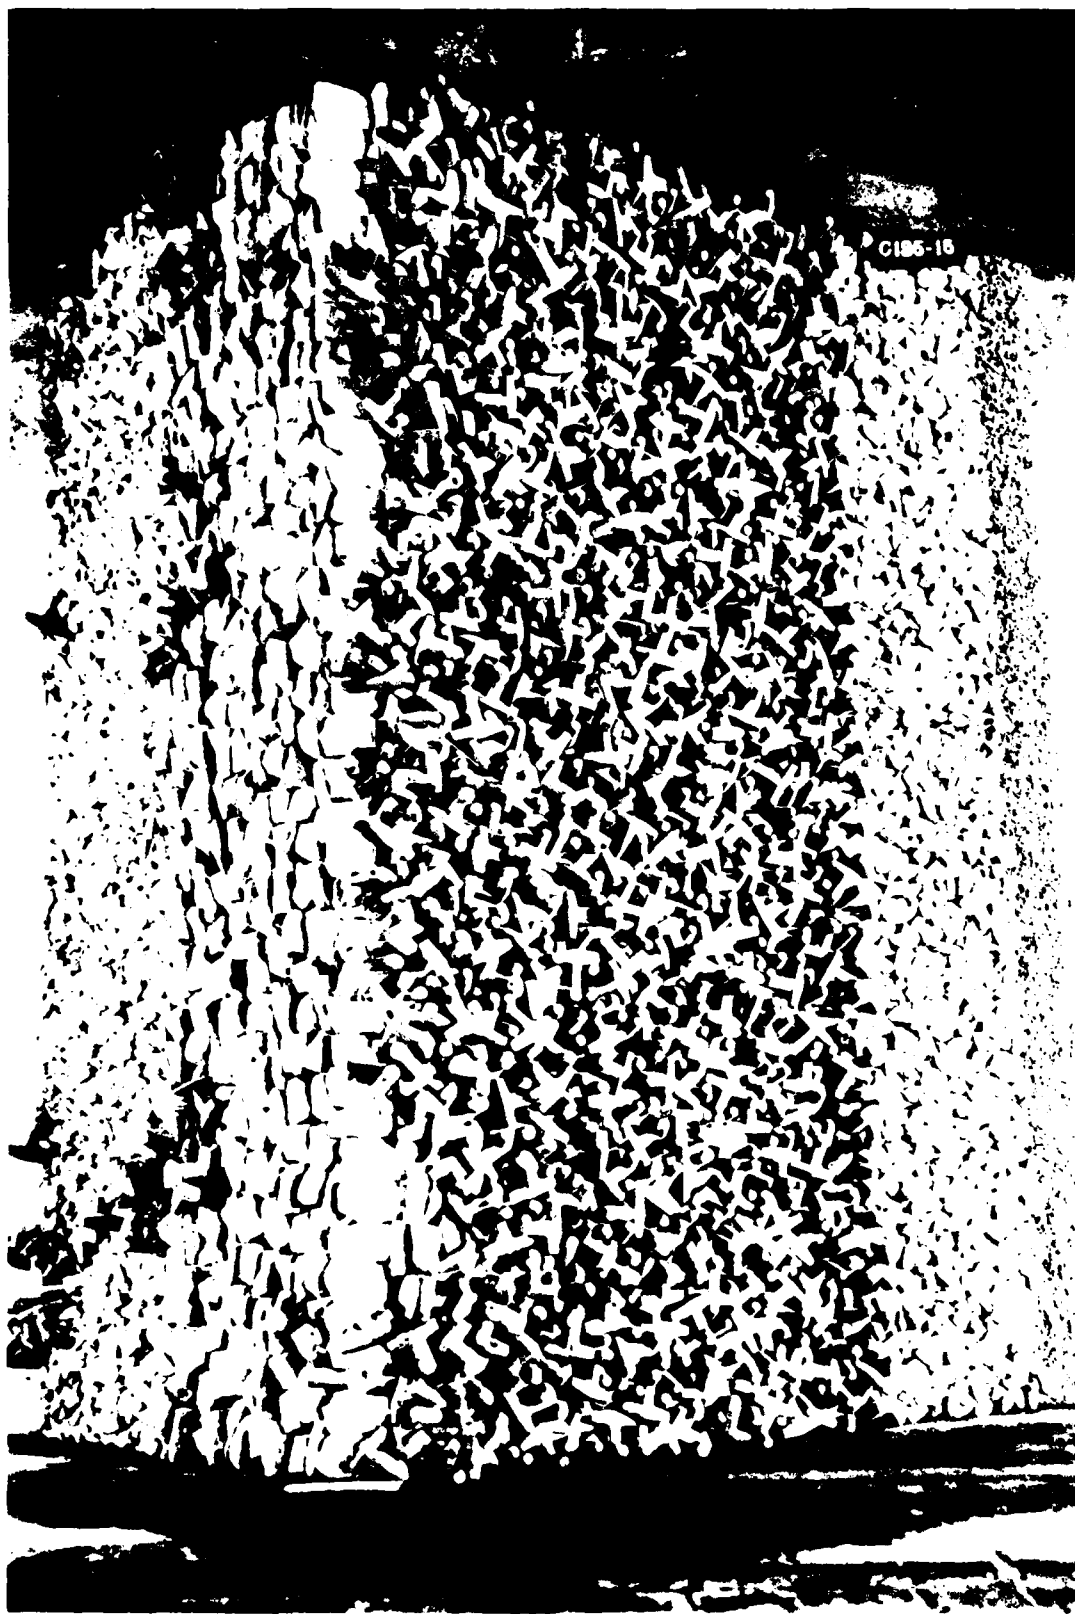
Photo 14. Overhead view of Plan 1 after testing Hydrograph A,  
second test section
